ERDC/EL TR-01-18

## **S-Tracker Survey of Sites for Long-Term Erosion/Deposition Monitoring**

**Final report**

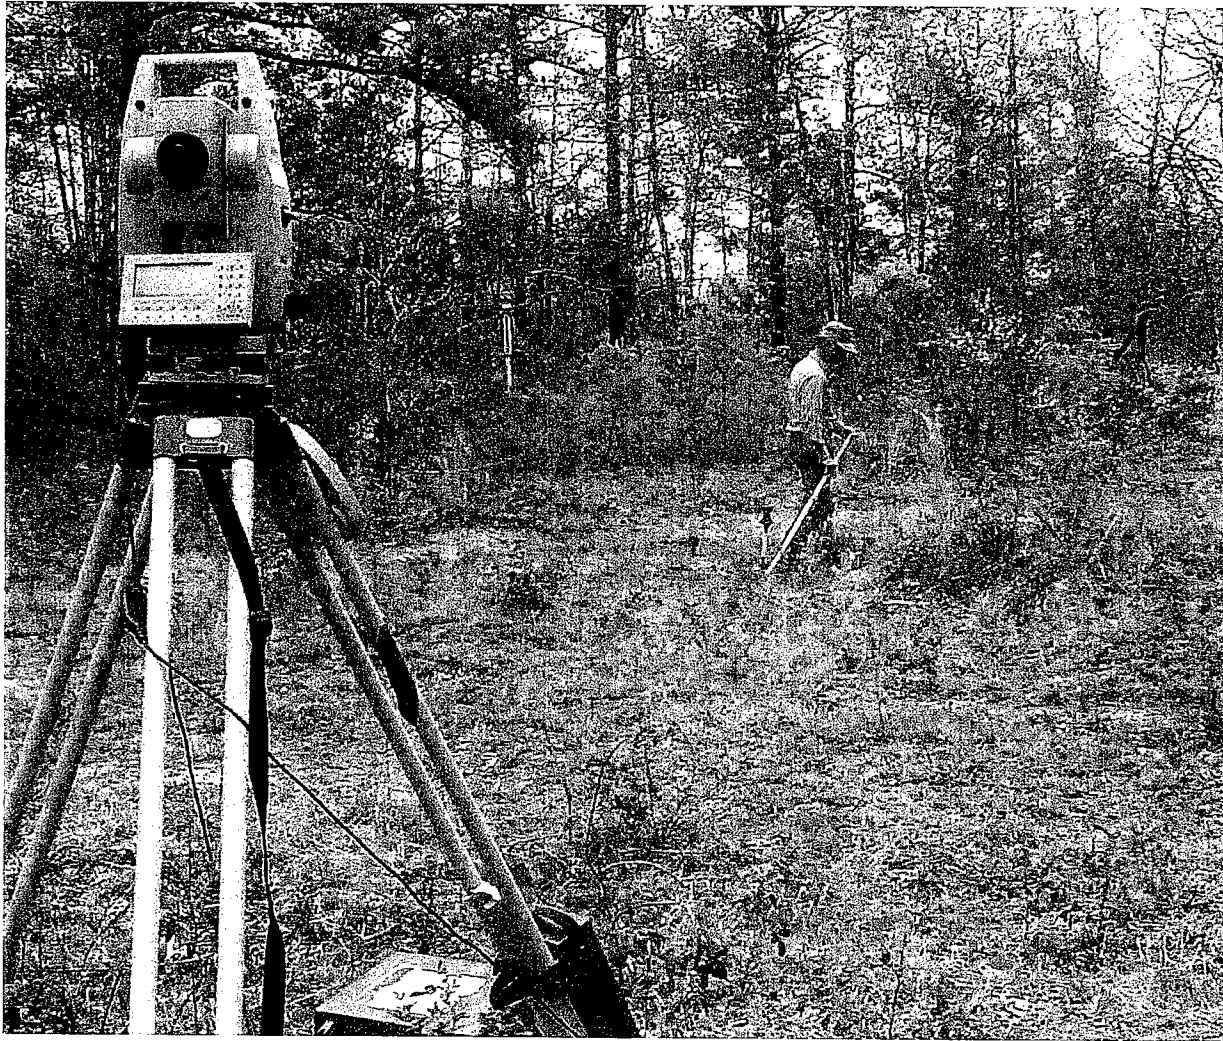
Figure 1. S-Tracker system with two instruments

<sup>1</sup> S-Tracker is an integrated hardware/software laser survey system that uses two or more robotic electronic theodolites and an optionally real-time kinematic global positioning system (GPS) to track sensor platforms with a prism moving over a course.

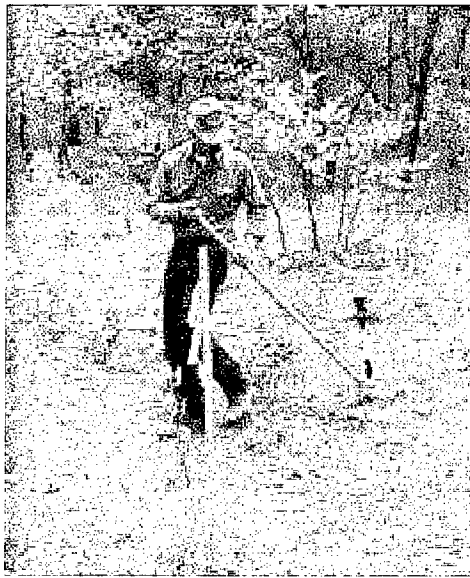
Figure 2. Prism on wheel

operator. The wheeled prism was then pulled across the site perpendicular to the apparent direction of slope. The survey process continued as long as at least two instruments maintained lock on the prism. If two instruments lost lock on the prism, the wheel operator was instructed to stop until all instruments were tracking the prism. The surveyed positions were recorded using the Geolink® Data collection software developed for the U. S. Army Engineer Research and Development Center, Environmental Laboratory. After all the transects had been measured, the setup information was saved together with the site topographic data on the field computer. After the field data had been collected, it was processed using the same Geolink software and output in an Excel spreadsheet file format, with four columns (time, X-coordinate, Y-coordinate, Z-value).

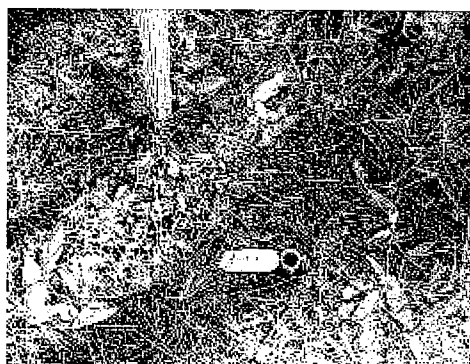
Figure 3. Corner pin and stake

Several sites were selected based on a restricted random grid procedure as potential sites for microtopography measurements. Ten sites were located in each of the Bonham Creek and Sally Branch watersheds, and, using a restricted random selection, the remaining 10 sites were selected from the existing land condition trend analysis (LCTA) transects. A 20- by 20-m data collection area was located at each site, and the corners marked with 91.5-cm (36-in.) steel pipes and wooden stakes (Figure 3). Because of very dense woody vegetation, a few sites were reduced to a 15- by 15-m area. Three instrument locations were then selected to optimize laser tracker visibility over the data collection area. An alternate (or backsite) location was also selected so that it would be visible from the three instrument positions. These locations were then permanently marked by driving a 91.5-cm (36-in.) or 122-cm (48-in.) steel pipe into the ground surrounded by a 15-cm- (6-in.-) diameter by 51-cm- (20-in.-) long polyvinyl chloride (PVC) pipe filled with concrete, topped with an aluminum hub. Each hub was stamped with the site name and the location ID.
